This is a Factual Investigative Update of a CSB investigation into a multi-fatality incident resulting from the catastrophic failure of a pressure vessel.¹ It provides the facts and findings established by the investigation team to date, which is subject to revision and updates as the investigation proceeds. This document identifies a path forward for a number of potential investigative areas of inquiry that may yield lessons for safety improvements.

Incident Overview

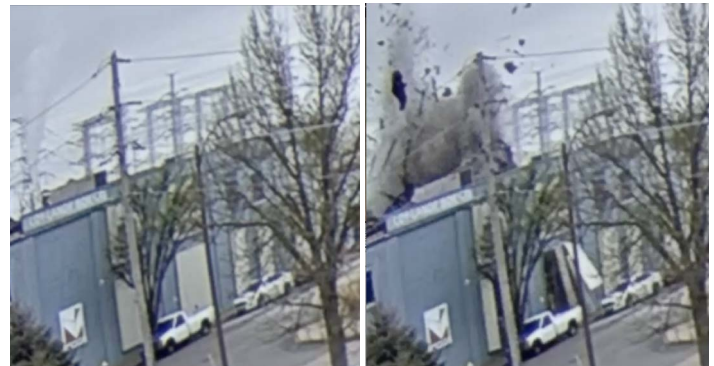
about 350 pounds of TNT.⁸ Some of that energy dissipated when the escaping steam condensed to water, but the surveillance video from a nearby custom work truck shop clearly shows the power of the explosion and the effect on the building (Figure 1), as does the damage evident after the event.

Figure 1. Before and after photos for the explosion - Kranz video

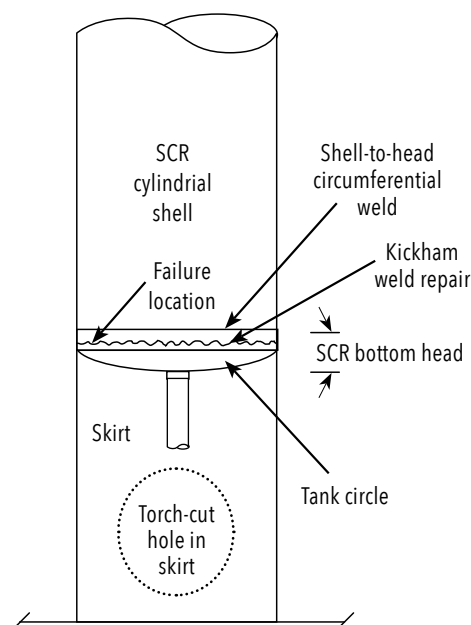
Figure 7. Drawing of various parts of the SCR

Figure 7 is a drawing that illustrates the various parts of the SCR, the failure location, and the pieces depicted in the photographs.

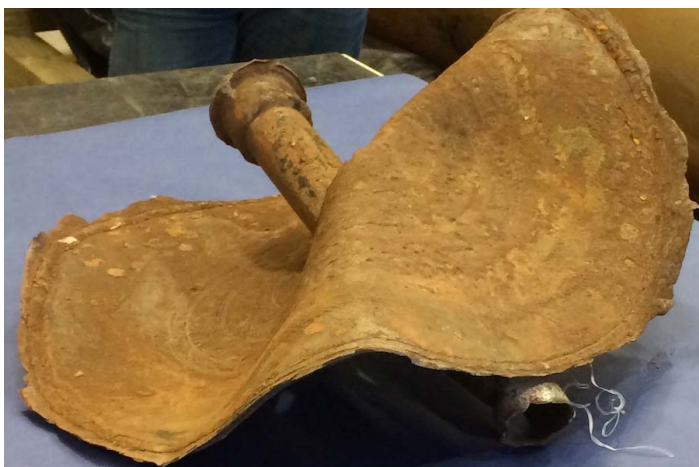
Figure 8. Close-up of bottom tank circle and portion of bottom piping showing weld seam and, outside of the seam, the thinned original bottom head “ring” material

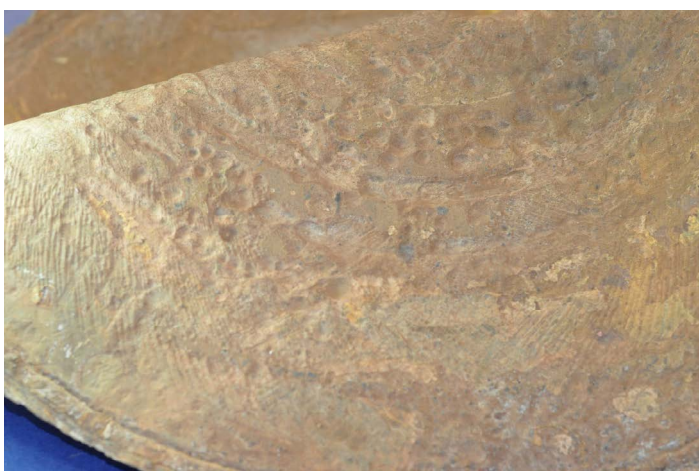
When the artifacts were removed, they were determined to be the entire tank circle that had been added during the 2012 repair and a portion of the bottom piping, Figure 9. The entire weld is intact, and around the outside edge of the weld is a portion of the 6" ring that mates with the portion that is still attached at the bottom edge of the vessel shell. Initial measurements of the remnants of this ring were as thin as 0.08". The metal of the tank circle, installed in 2012 and in service for 4.5 years, also displayed "surface of the moon" corrosion characteristics, and has thinned from the original 0.25" to about 0.2" (Figure 9). If the corrosion rate is assumed to be linear with time, this rate of corrosion of the tank circle is consistent with the rate on the original bottom head, as evidenced by the remaining ring material.³⁰ The corrosion in the bottom of the SCR was still occurring, as it did before the 2012 repair. Again, the team will rely on metallurgical testing and analysis in order to develop a further understanding of the corrosion damage.

Figure 9. Interior “surface of the moon” condition of the tank circle that separated from the SCR vessel during its catastrophic failure on April 3, 2017. The tank circle was installed in 2012

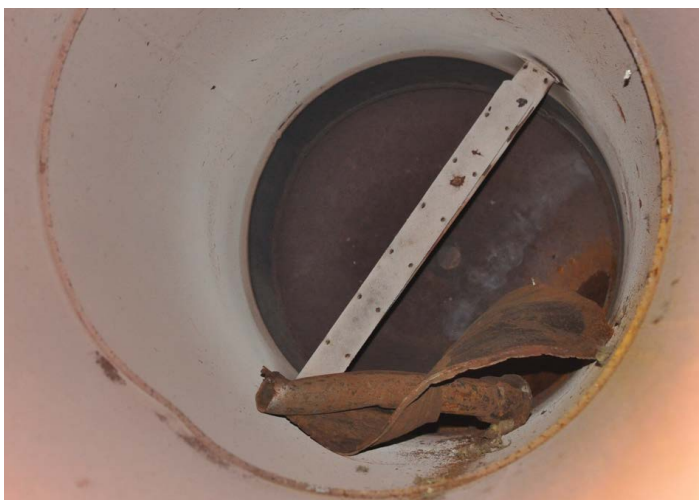
Figure 10. Piece of bottom drain piping and a section of the bottom head
