# Safety Alert: 15

Date: April 2021

## Filter Maintenance – care with metal castings

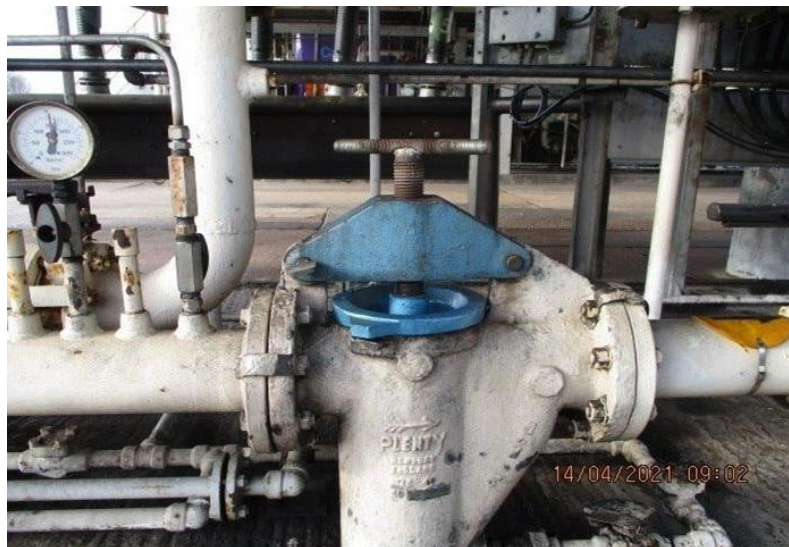
*Filter in position*

After completion of the scheduled maintenance the filter was re-installed. Additional force was applied with a copper hammer to ensure the filter lid was tightened and no leaks were present. As no vehicles were loading at the time of the maintenance activity, the loading pump had been shut down, however the line had been pressurised to complete a service test; this caused the cast-metal lid of the filter to fail resulting in a leak of approximately 308 litres of diesel. The site Emergency Shutdown (ESD) was immediately activated by staff, initiating the bay isolation valve (BIV) closure, and the area was made safe. The spill was contained on site.

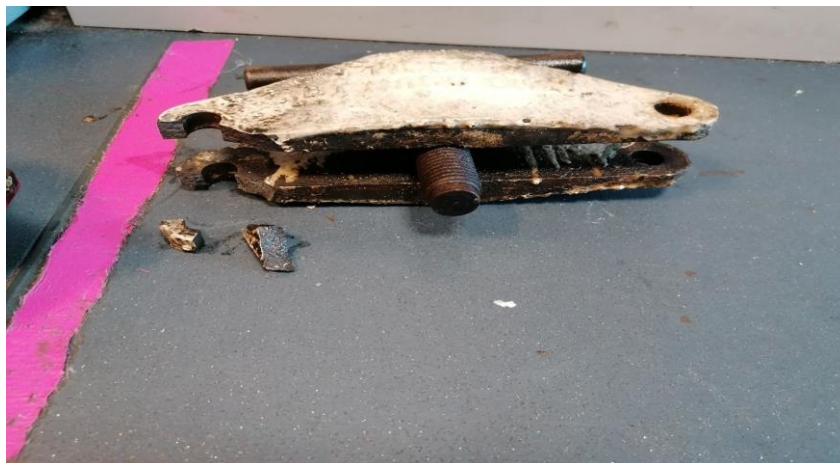
*Filter broken casting*

When leaks are detected after planned maintenance, there can be a temptation to use additional force to tighten filter lids to stop the leak. This filter lid is designed to be hand tightened only.

In addition, the sensitivity of cast iron to pressure pulses and over-pressurisation from volatilising liquor internally is a known hazard and all precautions should be taken to prevent this.

Risk assessments and maintenance procedures for planned maintenance activities on filters should emphasise the reasons for following manufacturers guidelines, in this instance hand-tightening only.

- Filter seals should be assessed to ensure that a leak-free seal is made using the manufacturers guidelines. Seals should be replaced if this is not the case.
- Filter lids should be examined for signs of damage.
