This is a Factual Investigative Update of a CSB investigation into a multi-fatality incident resulting from the catastrophic failure of a pressure vessel.¹ It provides the facts and findings established by the investigation team to date, which is subject to revision and updates as the investigation proceeds. This document identifies a path forward for a number of potential investigative areas of inquiry that may yield lessons for safety improvements.

Incident Overview

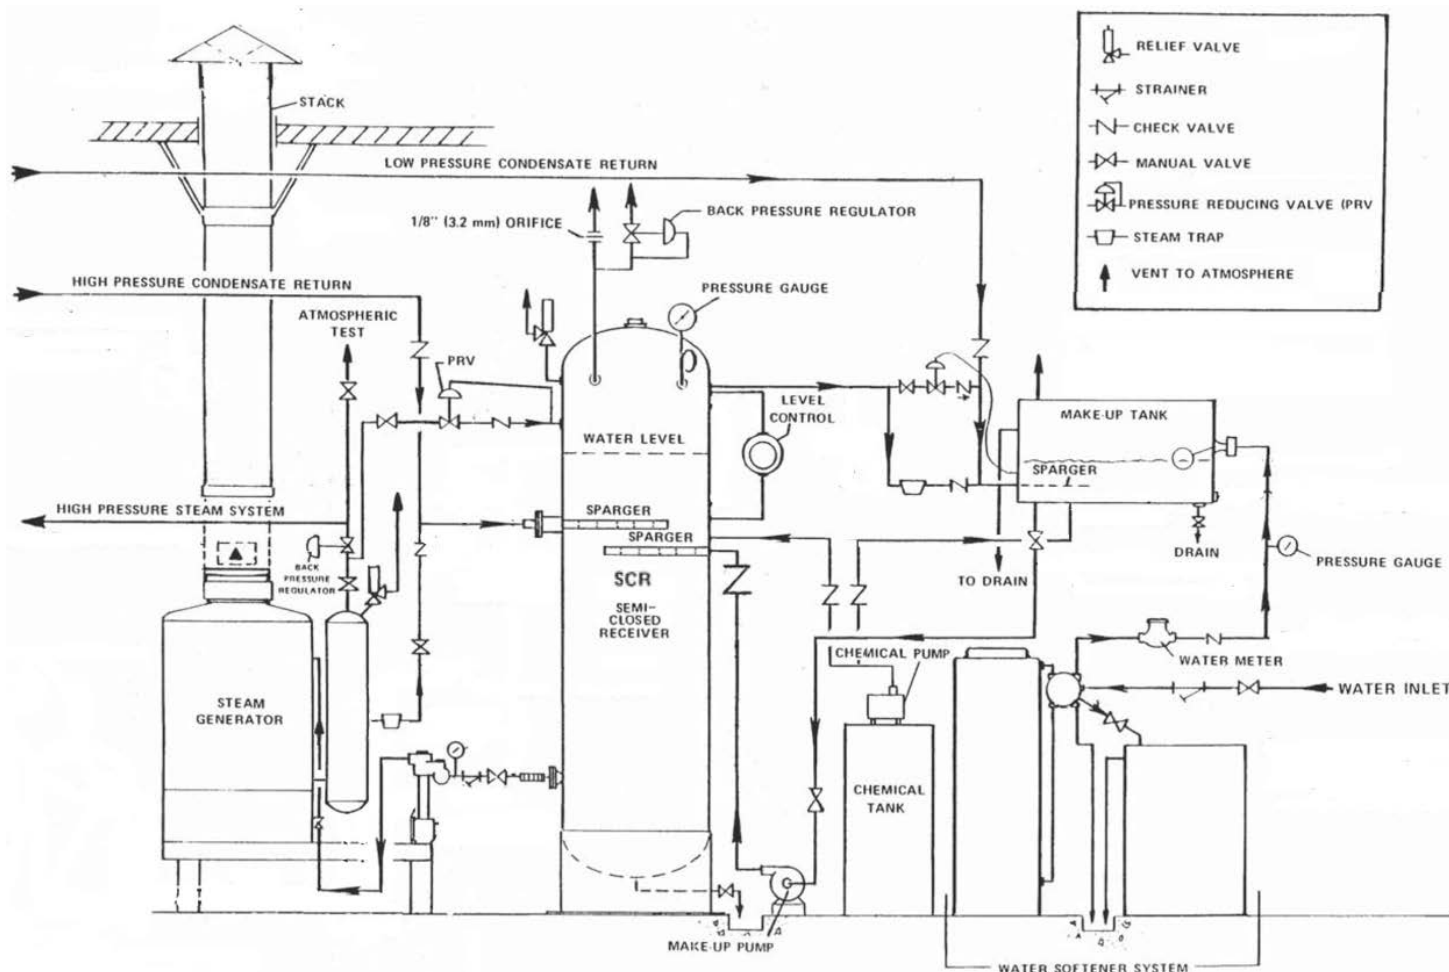
Figure 4. Clayton Steam Generator with Semi-Closed Receiver¹³

The steam generator (Figure 4, lower left) is a vertical cylinder filled with insulation and a tightly wound coil of tubing. Water from the SCR enters the top of the generator and flows down

through the tubing. Heat from natural gas burner¹⁴ travels up and heats the water. Steam and water flash into the adjacent vertical separator, and steam for the corrugation process exits the top. Any water in the separator is sent back to the SCR. At LLBC, the steam system runs at 175 psig and 375 °F.

the vessel. The skirt acts as a stand, and allows room for a bottom drain line (shown with dashed lines in Figure 4). This drain is used periodically (weekly at LLBC) to flush condensate to the sewer, with the intention of removing any sediments or contaminants that might collect there.
