ASBESTOS BUILDING

TYPICAL LOCATIONS FOR THE MOST COMMON ASBESTOS-CONTAINING MATERIALS

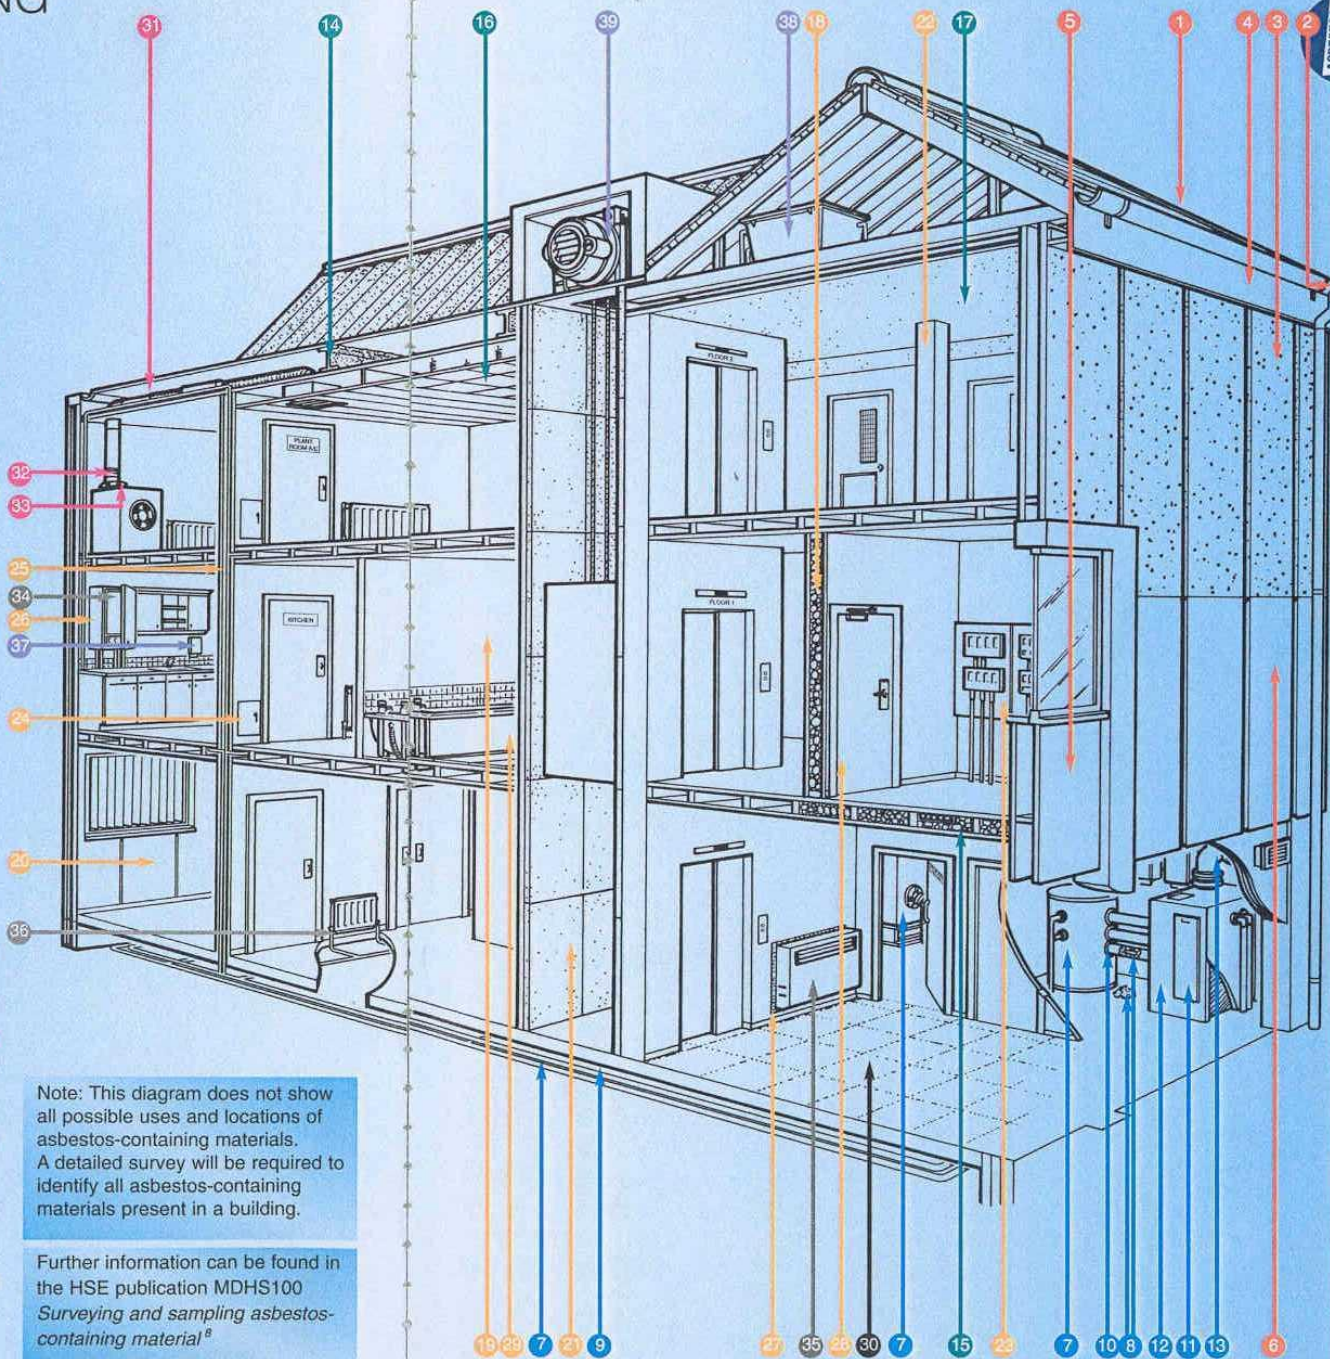
- 1 Roof sheets and tiles
- 2 Guttering and drainpipe
- 3 Wall cladding
- 4 Soffit boards
- 5 Panel beneath window
- 6 Roofing felt and coating to metal wall cladding

- 7 Lagging on boiler, pipework, calorifier etc.
- 8 Damaged lagging and associated debris
- 9 Paper lining under non-asbestos pipe lagging
- 10 Gasket in pipe and vessel joints
- 11 Rope seal on boiler access hatch and between cast iron boiler sections
- 12 Paper lining inside steel boiler casing
- 13 Boiler flue

- 14 Spray coating to ceiling, walls, beams/columns
- 15 Loose asbestos in ceiling/floor cavity
- 16 Tiles, slats, canopies and firebreaks above ceilings
- 17 Textured coatings and paints

- 18 Loose asbestos inside partition walls
- 19 Partition walls
- 20 Panel beneath window
- 21 Panel lining to lift shaft
- 22 Panelling to vertical and horizontal beams
- 23 Panel behind electrical equipment
- 24 Panel on access hatch to service riser
- 25 Panel lining service riser and floor
- 26 Heater cupboard around domestic boiler
- 27 Panel behind/under heater
- 28 Panel on or inside, fire door
- 29 Bath panel

- 30 Floor tiles, linoleum and paper backing, lining to suspended floor

- 31 Lagging
- 32 Gaskets
- 33 Anit-vibration gaiter

- 34 Gaskets, rope seals and panels in domestic boilers
- 35 'Caposil' insulating blocks, panels, paper, string etc in domestic heater
- 36 String seals on radiators

- 37 Fire blanket
- 38 Water tank
- 39 Brake/clutch lining

Note: This diagram does not show all possible uses and locations of asbestos-containing materials. A detailed survey will be required to identify all asbestos-containing materials present in a building.
